REPORT NO. B08.850.003.100

TESTING: Airtightness test carried out on the loft ladder according to EN 1026.

CARRIED OUT ON: **“MINKA – Loft Ladder, Type T 24 Royal Polar”**
Product description - see page 2

DATE: 16.06.2008

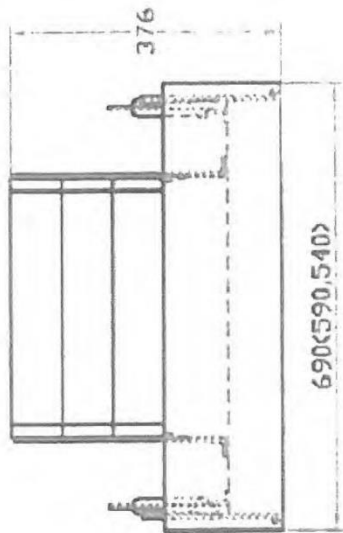
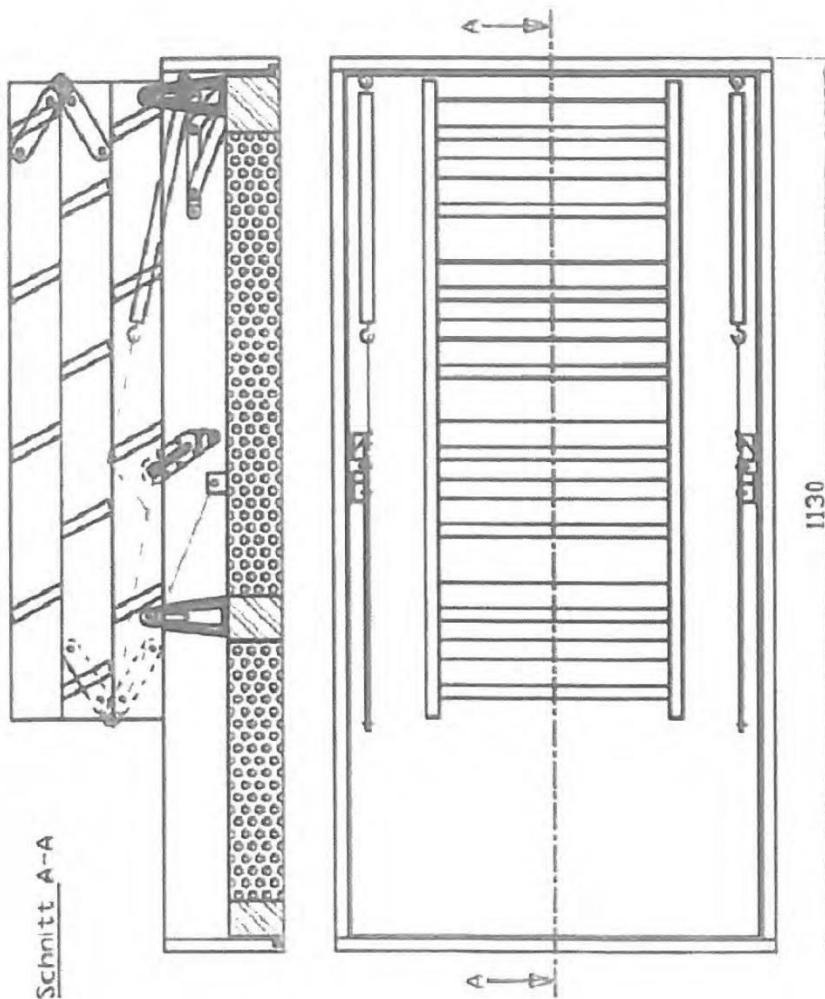
Picture 1, 2 and 3:
 The loft ladder that has
 been tested

The applicant selected and delivered the **"MINKA – Loft ladder, Type T 24 Royal Polar"** with single foam seal RAKU PUR 32-3218-7 in the feed box:

- 27 mm thick lining box of spruce solid bottom cover
- 3 mm hardboard
- 81 mm polystyrene plate
- 3 mm hardboard

Cover frame 81 mm thick concealed edge of spruce solid hinges and two locks on closure side (elliptical cones)

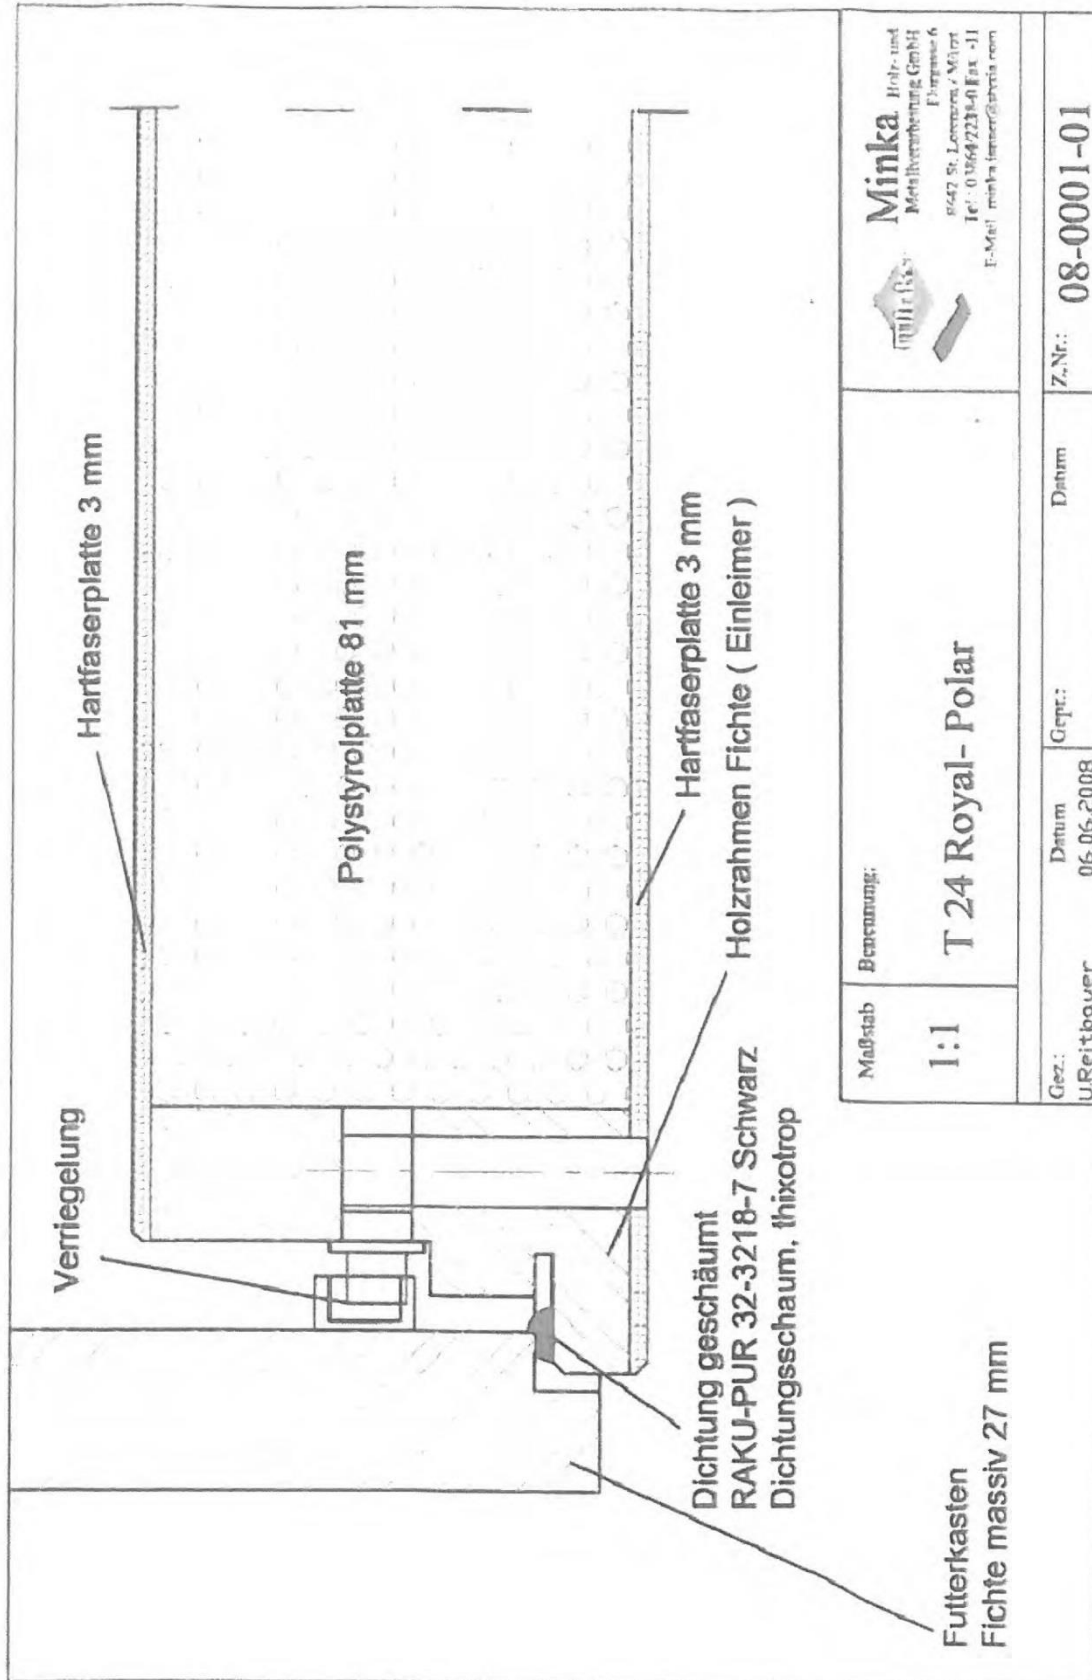
Figures 4 and 5: Loft ladder's lid and door frame
